## Index Plungers • for thin-walled pieces

22120.0266

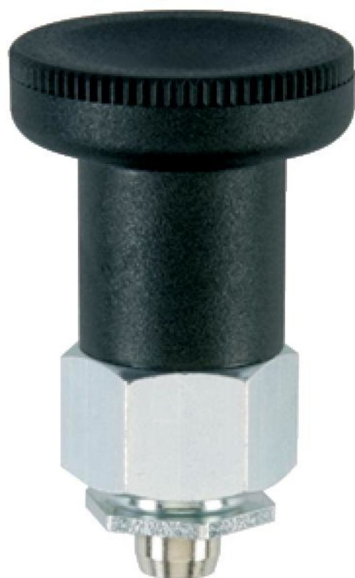
Index plungers with throughgoing bore for thin-walled pieces.

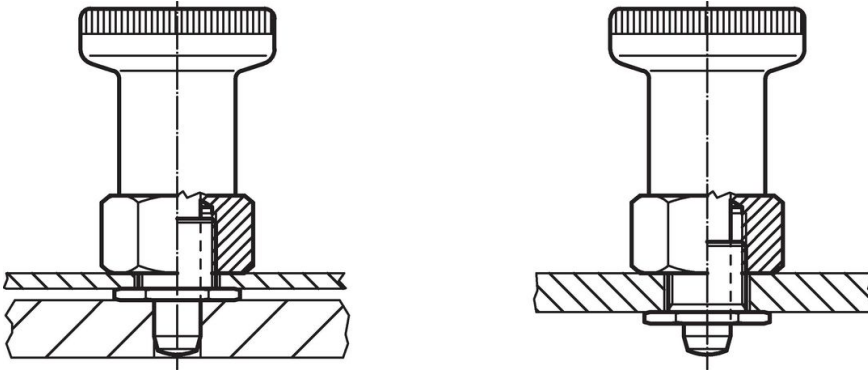
## Application example

By means of a fastening collet, the index plungers can be mounted into pieces having a wall thickness of 1-5 mm.
